Aging and Hail Research of PVC Membranes

Frank J. Foley, Jim D. Koontz and Joseph K. Valaitis

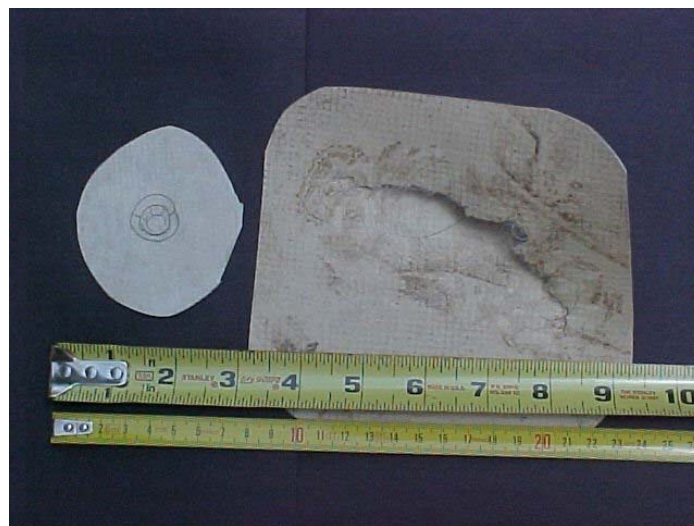
Photo 1: Small and large hail damage to two distinct PVC roof membranes

Photo 1 presents two samples of impact fracture on PVC roof membranes, both from hail. One is small hail damage taken from a roof in Conroe, Texas where the membrane was 18 months old. The other sample is of large hail damage taken from a roof in Fort Worth, Texas where the roof membrane had 42 months in exposure. The characteristic fracturing of the small hail sample in the photo is a series of concentric rings of fracture. This fracturing will also occur when a large and heavy object such as a large screwdriver is dropped onto an embrittled, membrane surface.

But what is the action of impact fracture? Impact fractures from hailstones are usually concentric arches of fractures (*Photo 1*). It is proposed that the failure mode at impact is about membrane distortion as opposed to an instantaneous surface shatter. A close-up view and slow-motion impact would reveal fractures not in a single moment of contact but rather in a timed sequence of elongation and subsequent fractures. As the projectile drives deeper additional distortion would create additional, outer rings of fractures. In this view, what role would reinforcement play in the prevention of fracture failure? It is conjectured that the reinforcement would provide a limit to distortion. The stronger and tighter the fabric weave, the more limited the distortion.
